GEL-COAT BLISTERING

Also known as: Osmotic Blistering or Gel-coat Chipping or Popping

FORM 65140

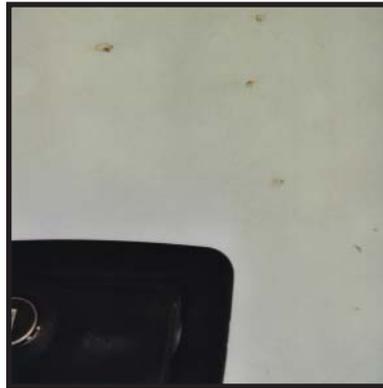
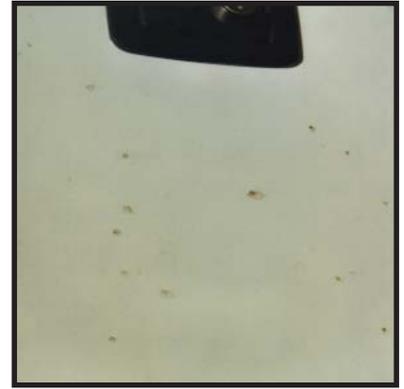
The occurrence of gel-coat popping/chipping/blistering is caused by the long-term presence of water to the backside of the fiberglass panel. When the lauan plywood substrate is saturated with water, capillary action moves the water through the fiberglass panel. The movement of the water through the panel continues until it hits the impervious gel-coat outer surface of the panel. Pressure builds behind the gel-coat layer as the trapped water is exposed to various hot and cold cycles. Gel-coat popping/chipping/blistering occurs when the built-up water pressure is greater than the bond of the gel-coat layer to the fiberglass substrate.

To eliminate the potential of re-occurrence to the popping/chipping/blistering problem on the panel surface, the source of the water to the backside of the fiberglass panel has to be eliminated. This will require the replacement of the saturated lauan plywood substrate and the correction of how the water is getting to the lauan plywood. Surface repair of the gel-coat popping/chipping/blistering area can be performed once the lauan substrate is dry, and the source of water is eliminated.

1. The source of water that is saturating the wood substrate must be located and eliminated.
2. The saturated wood substrate must be allowed to dry completely before proceeding to the next step.
3. Surface repair of the gel-coat can be done by utilizing the Crane Composites Repair Guide (form #65000), which can be found on the Crane Composites website at www.cranecomposites.com/pdf/65000.pdf
