GEL-COAT BLISTERING

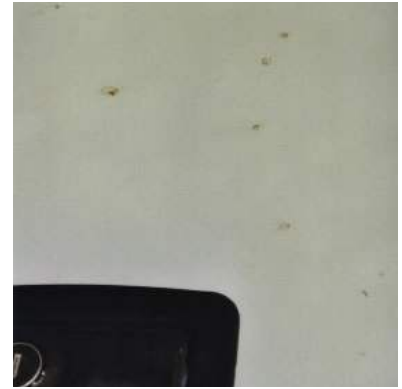
The occurrence of gel-coat blistering also known as Osmotic Blistering, Gel-coat Chipping or Popping is caused by the long-term presence of water to the backside of the fiberglass panel. When the lauan plywood substrate is saturated with water, capillary action, or capillarity which describes the ability of a liquid to flow against gravity in a narrow space, moves the water through the fiberglass panel. The movement of the water through the panel continues until it hits the impervious gel-coat outer surface of the panel. Pressure builds behind the gel-coat layer as the trapped water is exposed to various hot and cold cycles. Gel-coat popping/chipping/blistering occurs when the built-up water pressure is greater than the bond of the gel-coat layer to the fiberglass substrate.

GEL-COAT BLISTERING PICTURED

1. The source of water that is saturating the wood substrate must be located and eliminated.
2. The saturated wood substrate must be allowed to dry completely before proceeding to the next step.
3. Surface repair of the gel-coat can be done by utilizing the Crane Composites Repair Guide (Form # 65000), which can be found on the Crane Composites website at cranecomposites.com/rvrepair

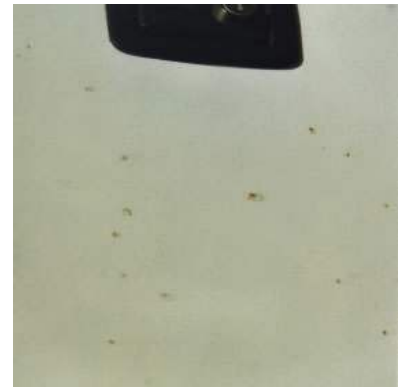
GEL-COAT BLISTERING PICTURED
